WL-TR-97-3093

**CORROSION AND FATIGUE STUDY
OF JSTARS AIRCRAFT**

Volume I

**NORTHROP GRUMMAN CORPORATION
MILITARY AIRCRAFT SYSTEM DIVISION
ONE HORNET WAY
EL SEGUNDO, CA 90245**

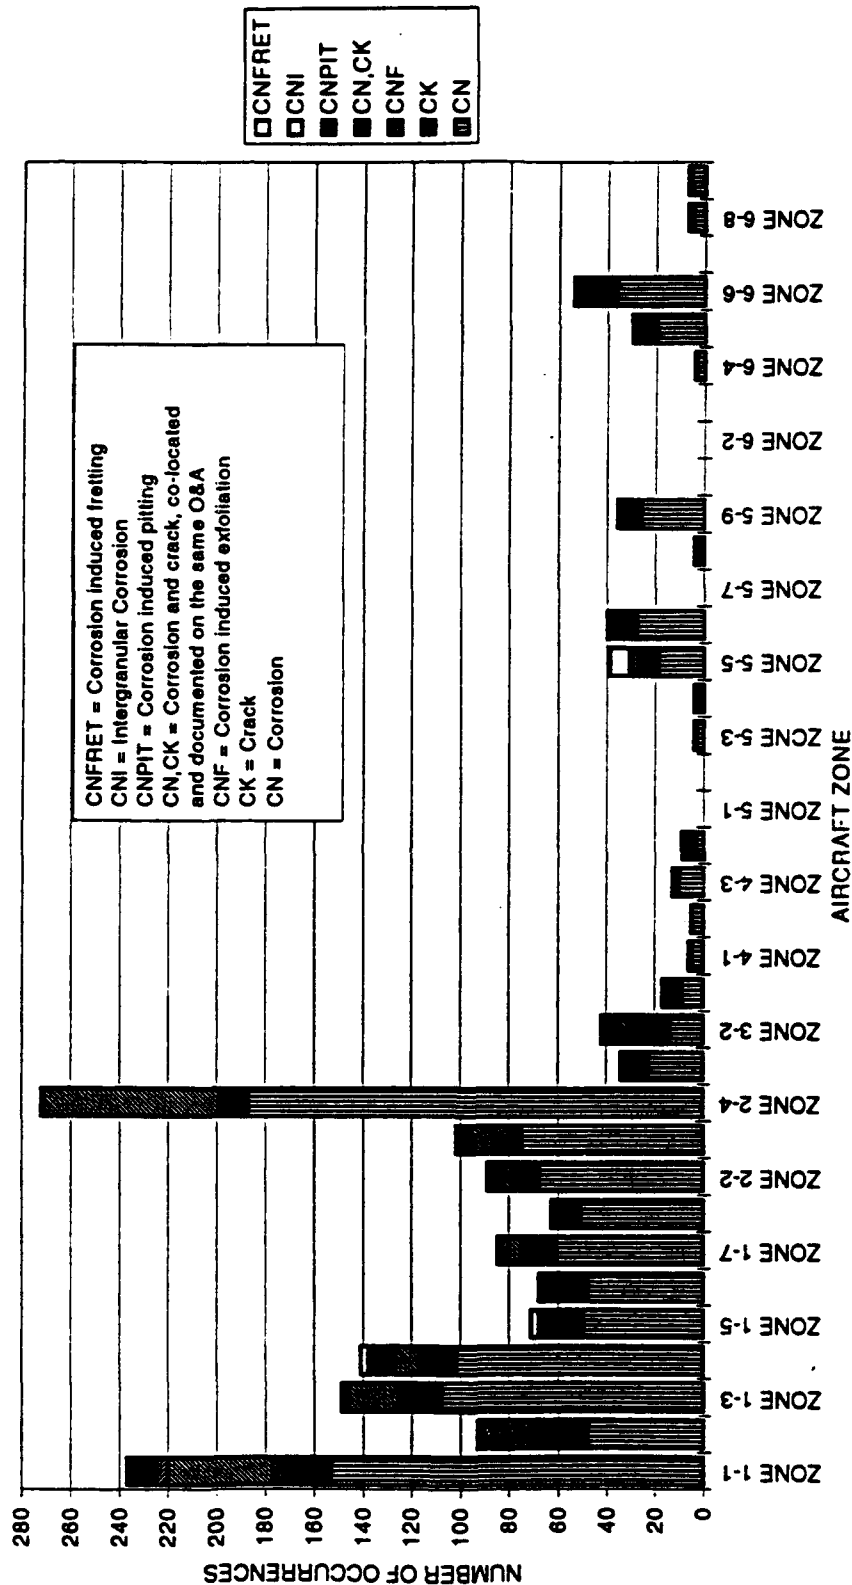
Figure 4.1 - Corrosion And Fatigue Damage Per Aircraft Zone On Joint STARS Aircraft P3 And P4

The areas of highest damage on the fuselage are in the following zones:

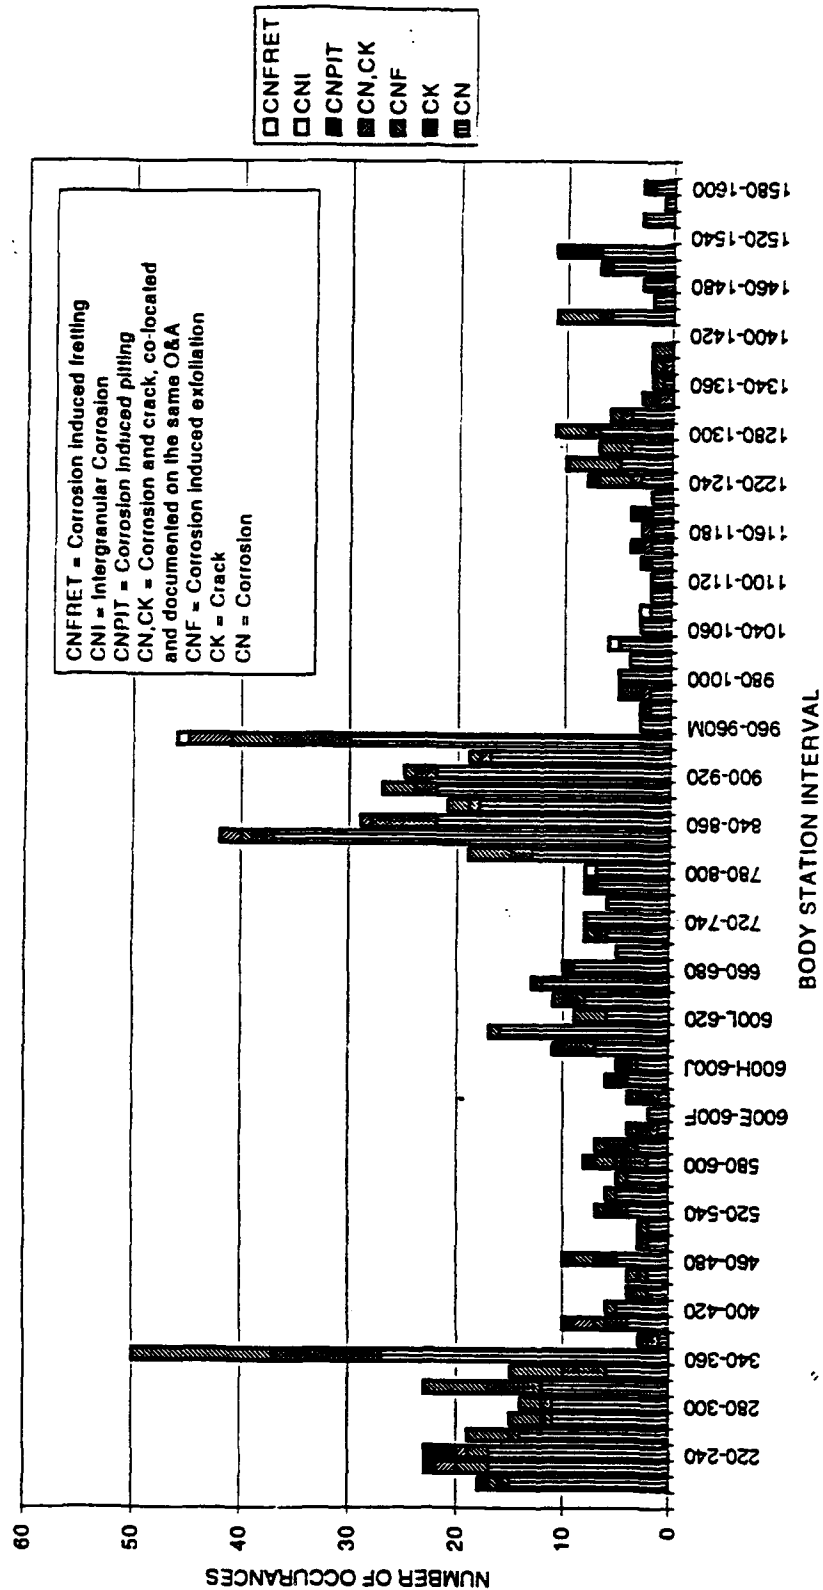
Figure 4.5 - Corrosion And Fatigue Damage On Internal Fuselage Structures Per 20 Inch Fuselage Segment On Joint STARS Aircraft P3 And P4

Figure 4.5 presents a higher resolution summary of the areas of damage on the internal fuselage structures. The aircraft fuselage is characterized by frame locations, which are spaced at 20 inch intervals. The high end of the segment coincides with the frame, when applicable (i.e. segment 420-440 would include the frame located at BS 440 but would not include the frame at BS 420). Aircraft zones are ignored. This analysis highlights specific areas exhibiting elevated levels of corrosion and fatigue damage. These areas are BS 200 to BS 360, BS 600K to BS 960, BS 1240 to BS 1320 and BS 1440 to BS 1520.

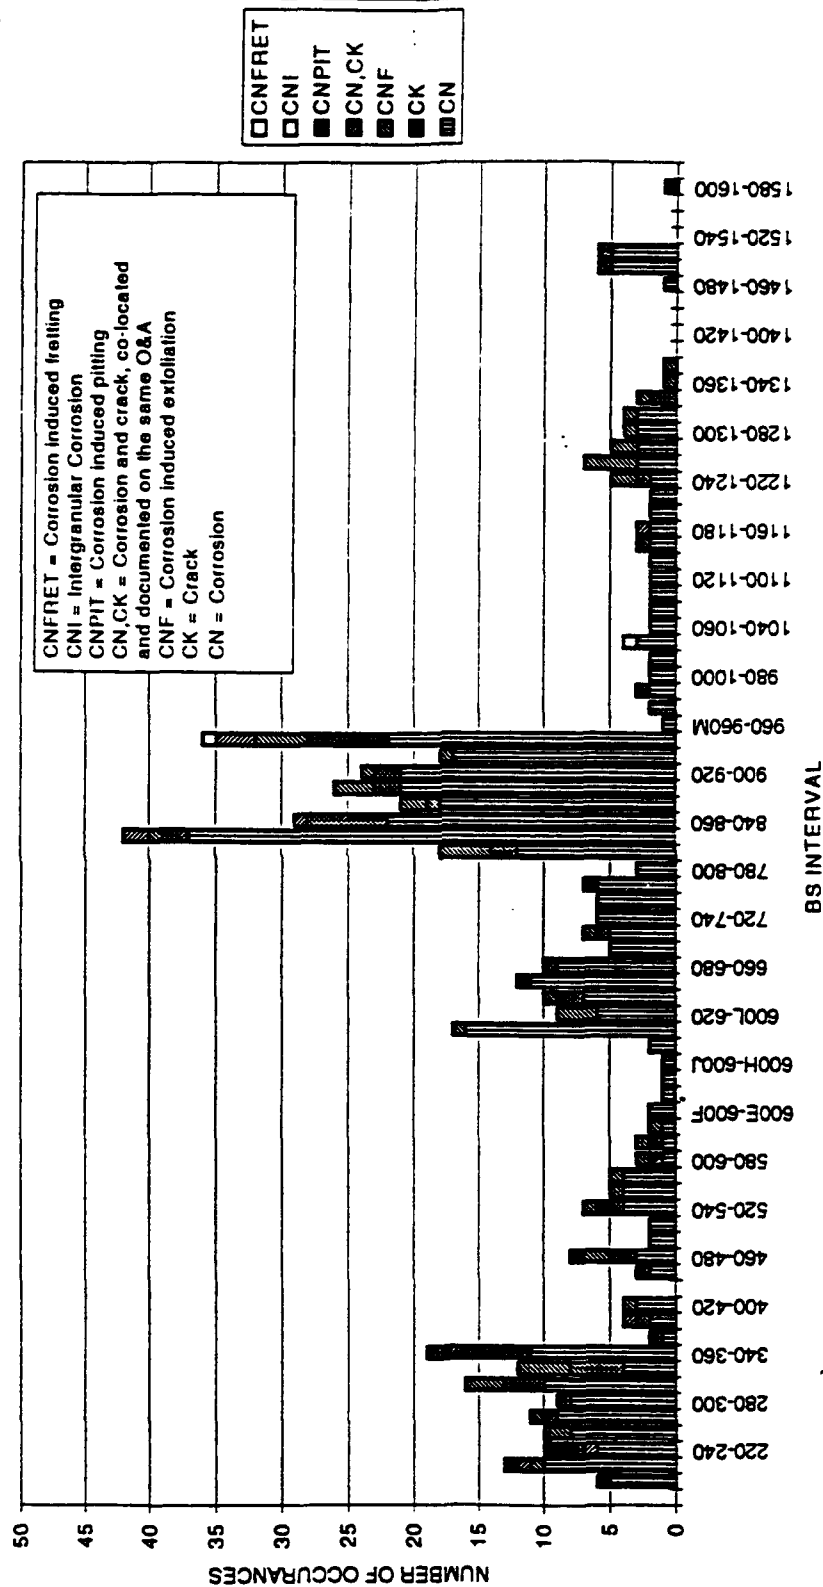
Figure 4.7 - Corrosion And Fatigue Damage Not Specific To Existing Frames And Bulkheads Per 20 Inch Fuselage Segment On Joint STARS Aircraft P3 And P4.

The corrosion and fatigue damage located between BS 200 and BS 360 can be largely attributed to the nose landing gear wheel well. The frames in this area, as shown in Figure 4.6, have a slightly elevated level of damage in comparison to the rest of the aircraft. The notable exceptions are BS 344 and BS 360, which display increased flaw density. As shown in Figure 4.7, the majority of the flaws between BS 200 and BS 360 are not associated with specific frames. Rather, they are located in the inter-frame structures specific to the nose landing gear. The non frame specific damage sites in addition to the flaw density on frames 344 and 360 make the region between BS 200 and BS 360 in zone 1-1 the most severe corrosion and fatigue damage site for internal fuselage structures.

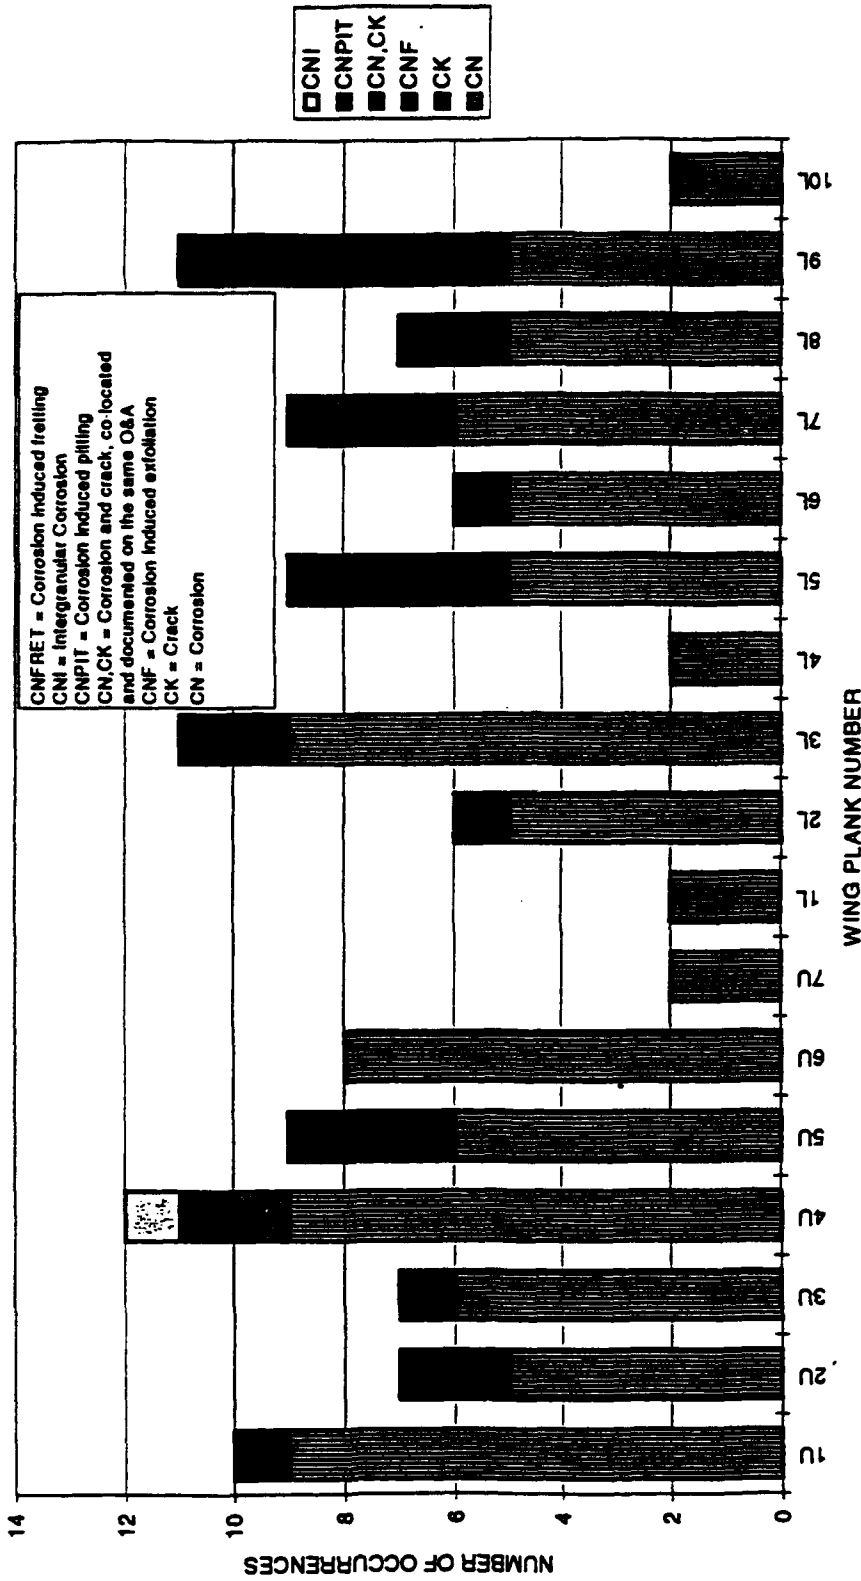
Figure 4.14 - Wing Plank Corrosion And Fatigue Damage Per Wing Plank Number On Joint STARS Aircraft P3 And P4.

A summary of the levels of damage specific to wing plank number is presented in Figure 4.14. This summary does not account for aircraft zones. The level of corrosion and fatigue damage sites remains fairly constant with respect to wing plank number except for wing planks 7 UPR, 1 LWR, 4 LWR and 10 LWR which exhibit relatively low levels of corrosion damage and the absence of fatigue damage.

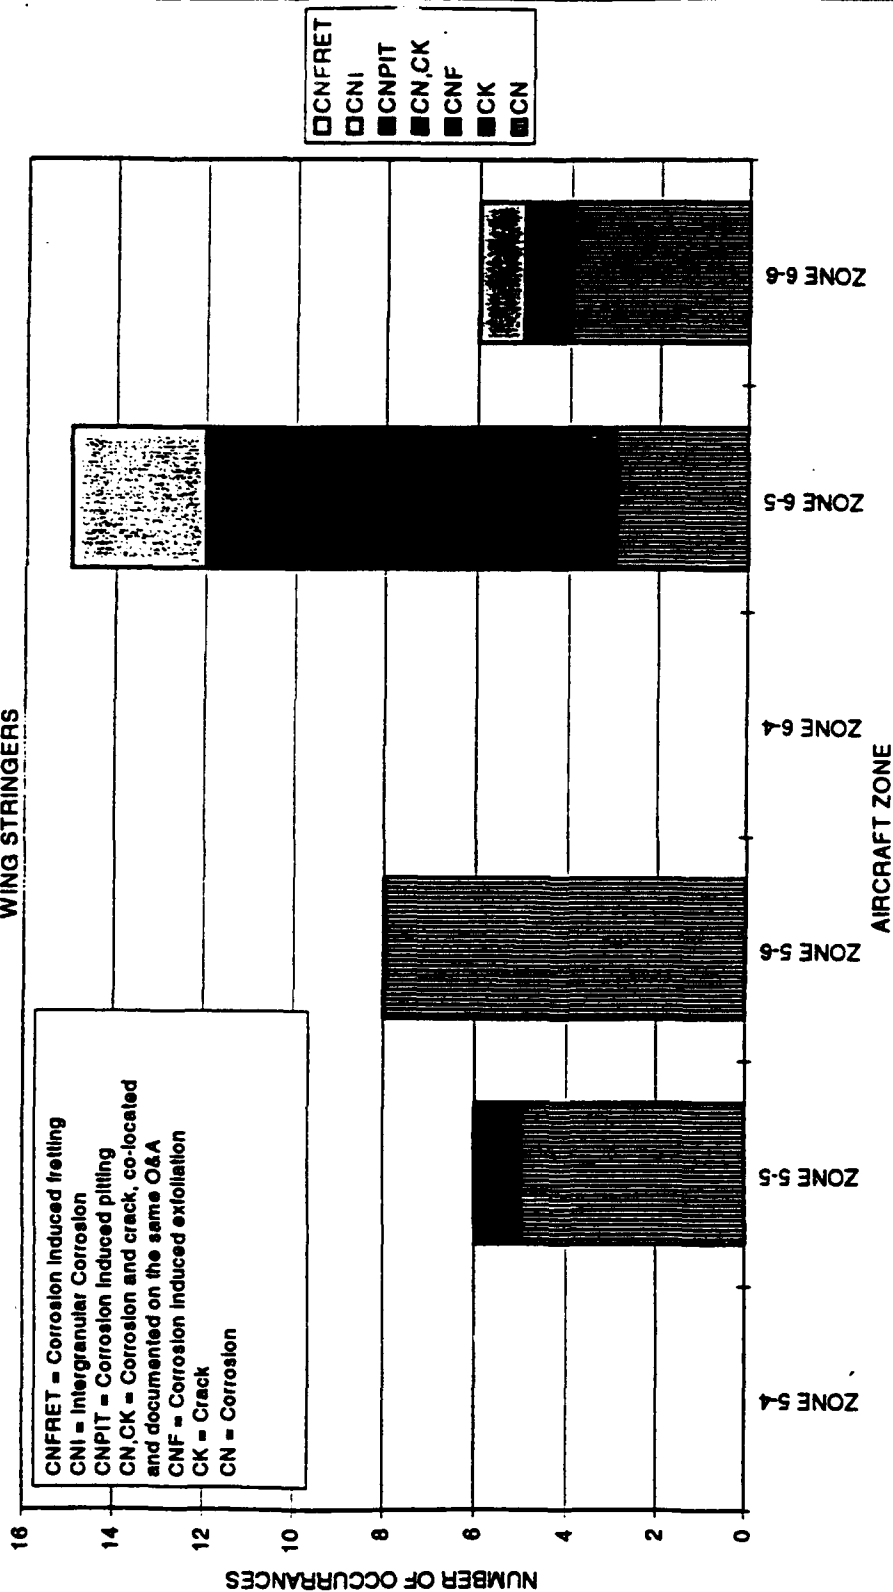
Figure 4.15 - Wing Stringer Corrosion And Fatigue Damage Per Aircraft Zone On Joint STARS Aircraft P3 And P4.

A breakdown of the damage locations on the wing stringers with respect to aircraft zones reveals much the same trend observed in the wing planks. The levels of damage remain elevated in the inboard and mid wing interspar areas (zones 5-5, 5-6, 6-5, and 6-6), then drops drastically in the outboard wing zones, where there is a complete absence of damage (Figure 4.15). As noted before, the high level of cracking in zone 6-5 is specific to P-3 only.

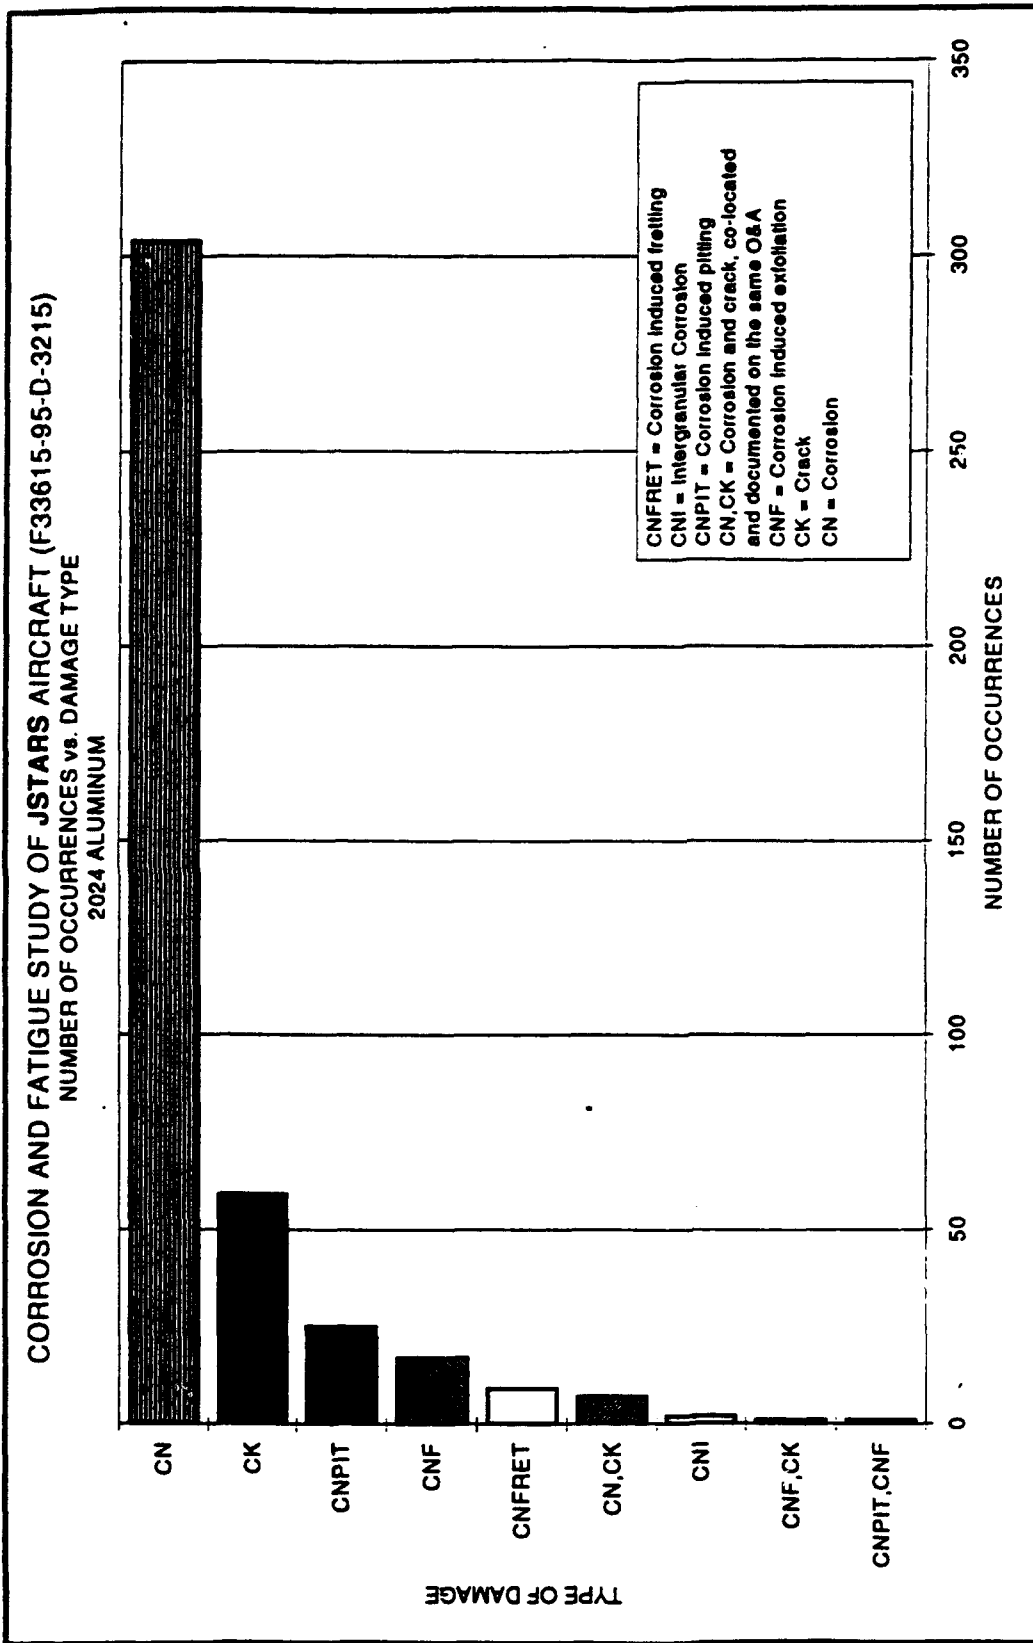
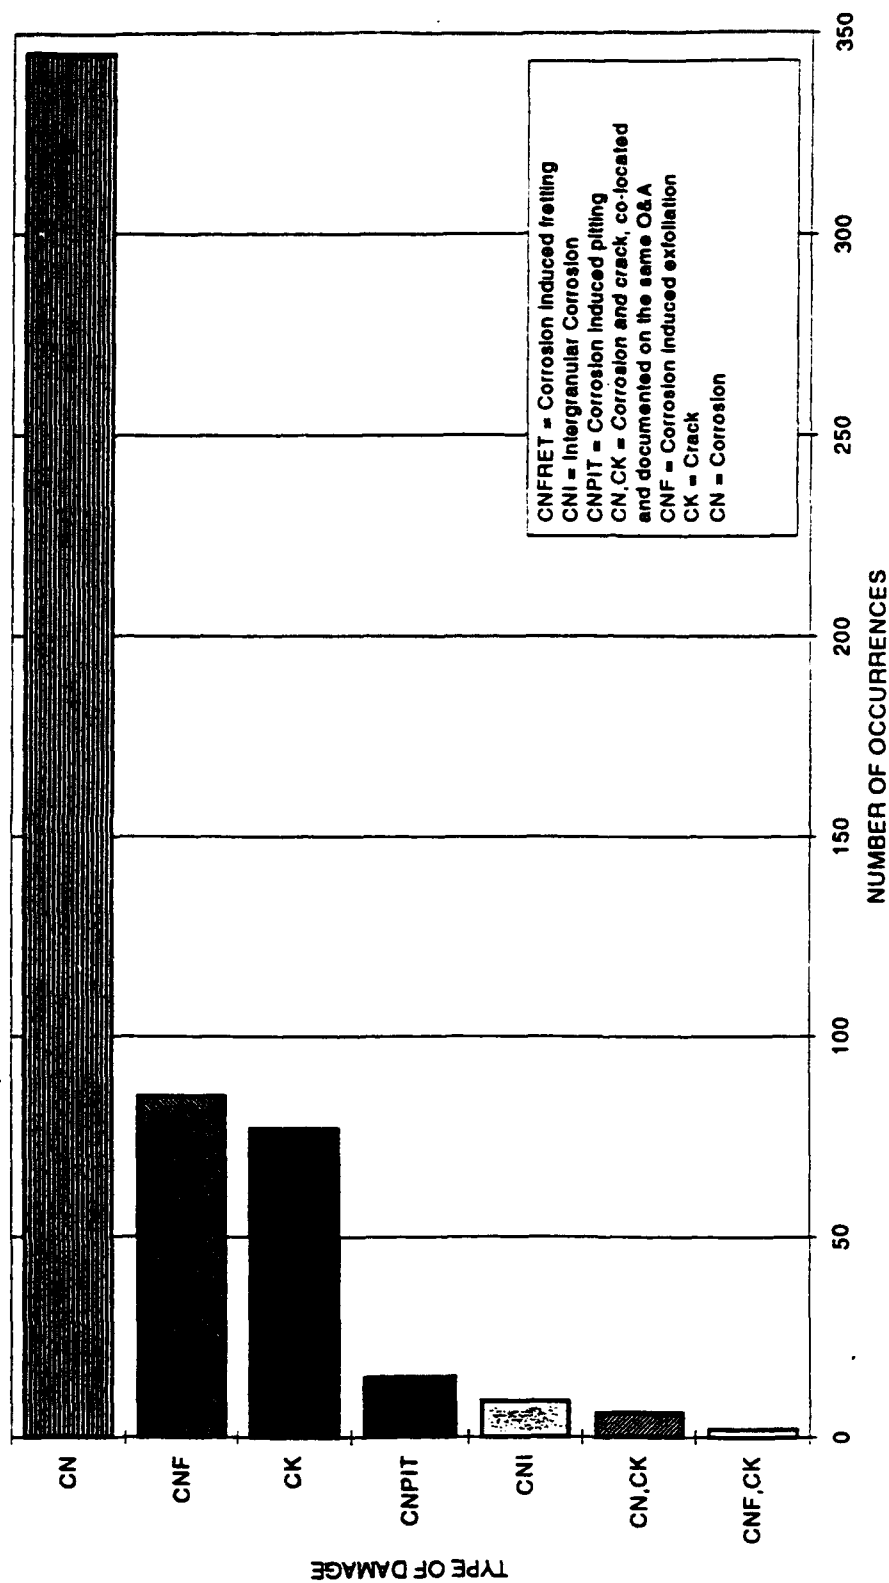
Segregation of the damaged elements by material and part form fails to highlight any significant trends. The two most prominent materials on the aircraft are 2024 and 7075 Aluminum. In both materials, the most prominent type of damage is simple corrosion, accounting for 71.5% of the damage sites identified as 2024 and 64% in 7075. This prevalence of corrosion damage is maintained, though at different percentages, regardless of part form. See Figure 4.16 and Figure 4.17.
